# Manhole Inspection Summary

## Manhole # S19KK\_004MH

Insp Date: **6/6/07 7:32 AM**

**Location** Address: **1947 CLIFTON AVE**

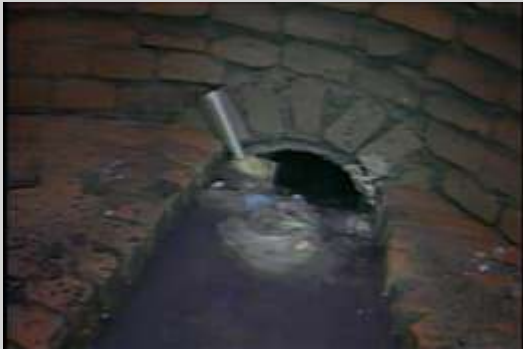
12 O'Clock Outflow

DEBRIS IN CHANNEL

Pipe Height: **9.6** (in.) Rod and Bar (Angled)  
Pipe Material: **Clay** ☐ Pipe Lined  
Invert Depth: **6.11** (ft.) Flow Characteristics: **Slow**  
Deposits: ☐ None ☐ Mud ☐ Sludge ☒ **Debris** ☐ Grease  
Silt Depth: **6** (in.) Deposits Extent: **Heavy**  
Infiltration: **None** Pipe Seal Cond: **Sound**

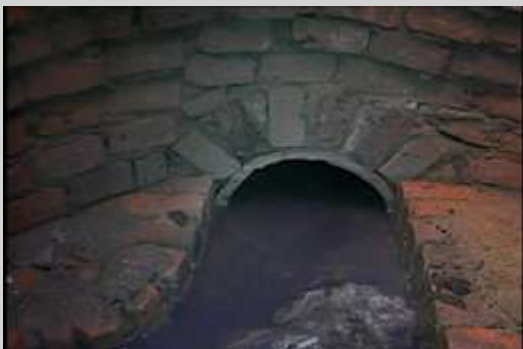
3 O'Clock Inflow

Pipe Height: **9.6** (in.) Rod and Bar (Angled)  
Pipe Material: **Clay** ☐ Pipe Lined  
Invert Depth: **5.91** (ft.) Flow Characteristics: **Slow**  
Deposits: ☐ None ☐ Mud ☐ Sludge ☒ **Debris** ☐ Grease  
Silt Depth: **3** (in.) Deposits Extent: **Medium**  
Infiltration: **None** Pipe Seal Cond: **Sound**
